National Register of Historic Places Registration Form

This district incorporates the largest group of Rustic Style structures in the park, as well as a number of structures associated with the pre-park and pre-NPS settlement and development of the area. Fifty-eight structures and sites within the district's boundaries are considered to be contributing structures. The district itself is divided into two distinct areas by the Nisqually-Paradise Road; the Longmire Meadows to the north where the Longmire family established their homestead claim and built the first resort; and the complex of concessionaire and government-built facilities to the south. Within the Meadows area, which is circumnavigated by the Trail of the Shadows, is the Longmire Cabin, the two springs enclosed by stone parapet walls--Iron Mike and Soda Springs--and the site of the Longmire Springs Hotel. South of the road, the buildings are grouped into functional areas: administrative and visitor services, residences, and maintenance. To the far south, across the Nisqually River, is the Community Building (1927) which serves visitors using the nearby campground and other facilities at Longmire.

See the attached PNR I

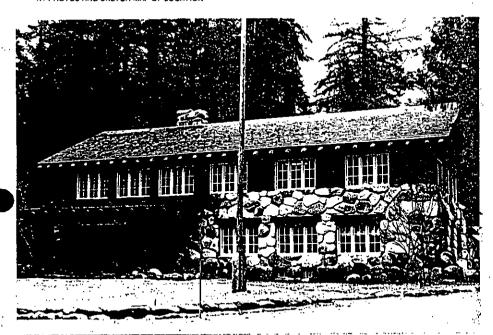
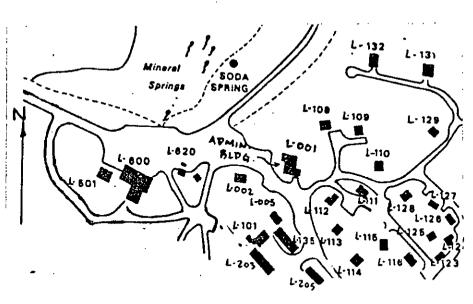
The most striking portion of the building (generally measuring 37' x 68') was the first story, boulder-masonry veneer. Local glacial boulders were employed with the more massive stones embedded in concrete at the base. The size was decreased upward to the second story. Stones were battered at the building's corners to lend a solid appearance and mask the "essentially rectangular foundation lines." The second story, horizontal log slab veneer arising at sill level was joined at the corners by massive vertical logs. Projecting whole log rafters with whittled ends were connected to the non-visible standard timbers forming the rafters. The roof was covered with cedar shingles. These elements combined to create a structure highly sensitive to the forested landscape.

^{16.} SIGNIFICANCE Upon its completion, the Longmire Administration Building was perhaps the most widely acclaimed building in the park. Its design was supervised by Thomas C. Vint. Chief Architect of the National Park Service, Western Division, Branch of Plans and Design. Vint was responsible for continuation of "non-intrusive" rustic architecture: in the West's National Parks between 1927 and 1937. Associate Landscape Architect E.A. Davidson worked under Vint on the landscape development of Mount Rainier National Park including the administration building. The distinctive glacial boulder veneer and log work set in the forested environment, is a product of their collaboration.

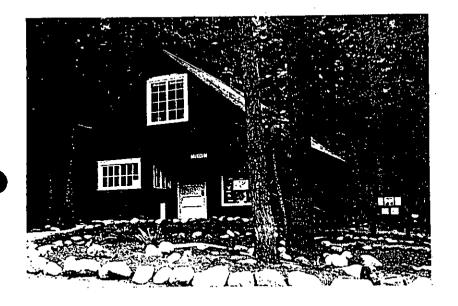
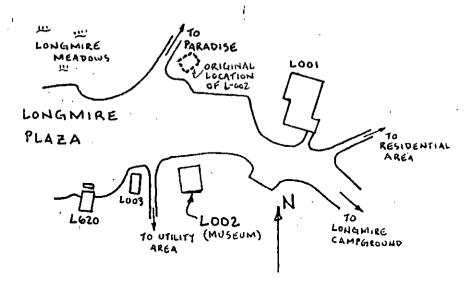
Constructed during the administration of Superintendent DeWitt L. Reaburn, the building was the first permanent park headquarters. It functioned as an administrative facility for over a decade. Its conversion to a museum and visitor's information center exemplifies the early emphasis placed on interpretive programs by the National Park Service. The Longmire Museum and Visitor's Center remains largely unaltered from the time of its remodeling in 1931. It continues to function as an interpretive center.

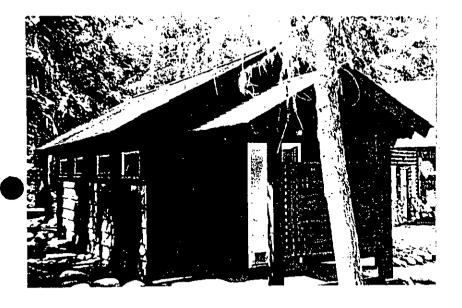
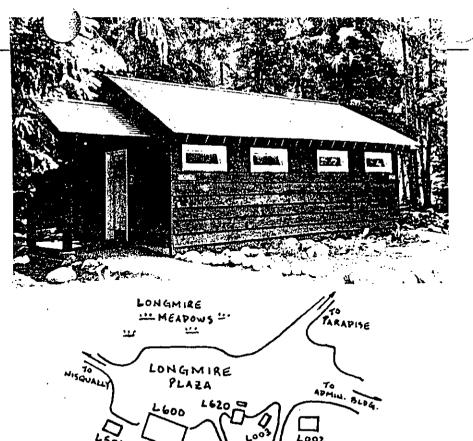
. Timber-frame: 1-story; rectangular plan; medium-pitched cedar shingle gable roof with projecting eaves and verges: porches with cedar shingled gable roof at each entrance; rough lapped Douglas Fir siding; front center entrances at each end; pivot windows; marlite walls and ceilings; concrete floor covered with tiles; concrete foundation.

Comfort Station L-003 was built as part of the Longmire plaza improvement in the twenties. It is the oldest remaining comfort station in the park.

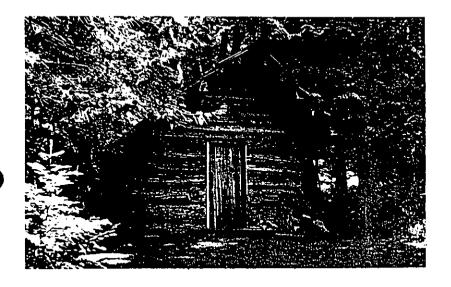
Log frame, one story, one room, rectangular cabin; steeply-pitched cedar-shaked gable roof; deeply projecting gable verges; quarter log purlins; unhewn half-cut fir log walls; saddle-notch cornering; wood chinking; log sill on concrete foundation; exposed roof framing beams (purlins) on ceiling; unfinished interior log walls; split cedar plank floor.

The Longmire Cabin has been considered eligible and nominated to the National Register of Historic Places.

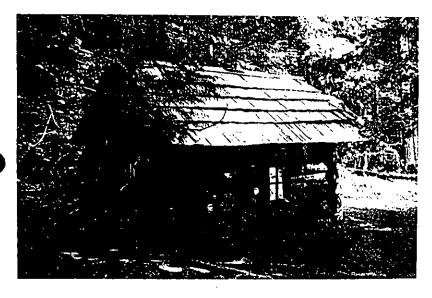
17. PHOTOS AND SKETCH MAP OF LOCATION

poured concrete foundation. The supervisor of the 1970 rehabilitation remarked that none of the logs looked old enough to be from the original construction (Schieber, 1982).

Presently, the logs exposed to the soil at the base are rotting. The cabin has been a victim of minor vandalism in the form of graffiti, litter, and a broken window.

the National Park Service replaced the roof and base logs, installed new floor joists and a new floor, and added a

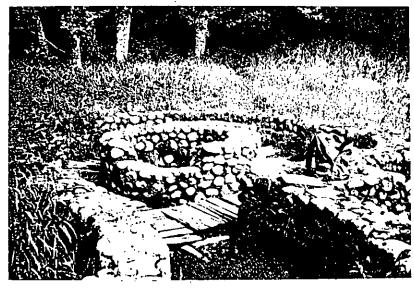
IRON MIKE SPRING

Iron Mike Springs, adjacent to the Longmire cabin, obtained its name from the high iron content of its waters and rust color of its deposits. The circular stone masonry enclosure, and the concrete steps and walkway, are surrounded by a rectangular, stone parapet wall. Both walls are moss covered, with stones missing in several places.

Only two of the springs, Iron Mike and Soda, retain their stone masonry walls.

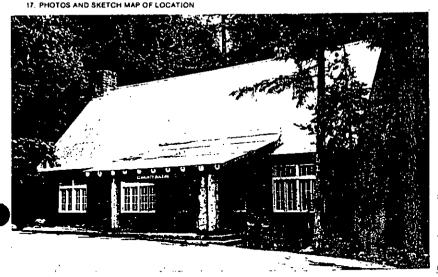
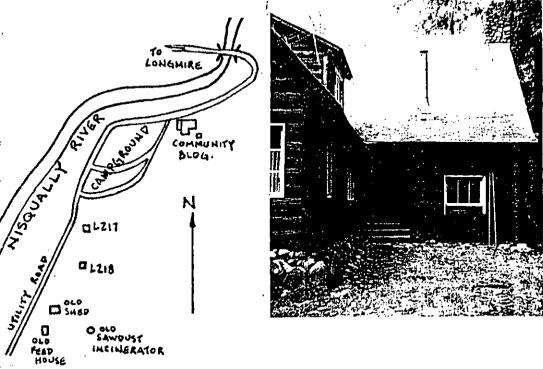
The Community House completed in 1927 was the crowning achievement in the construction of the Longmire Public Auto-Camp (1924-27). For decades it served as the center for cultural and social activities at Longmire. The building, designed by the NPS Western Division Branch of Plans and Design, Thomas C. Vint, Chief Architect, typifies the theme of non-intrusive, "rustic" architecture prevalent in America's parks in the twenties and thirties. It remains largely unaltered and functions in much the same role (though less extensively used) as originally intended.

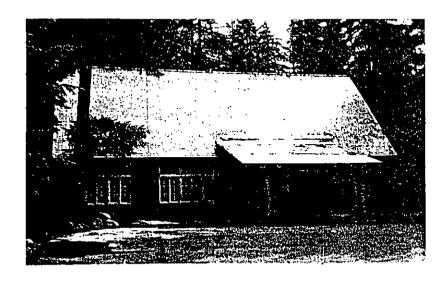
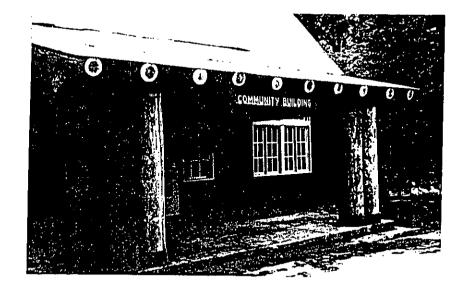
NPS employees.	The Community Building	currently serves in its		role though	n in a redu			hile no			
			<u></u>	15. DANGER OF (SPECIFY TH	REAT)	1.20					
have occurred to severe rot). It unknown date, to finsulation a metal flashing.	o the building. In 194 he projecting whole log he exposed whole log ri nd re-installed (as ori New whole log posts r log rafters, the porch	e, the main hall is stil 2, an entire new wood fl rafters also deteriorat dge beam was removed. R ginal). The shed roof o eplaced several deterior appears as originally co	oor was ir ing from r ecently, t n the porc ated ones.	nstalled to not were cut the log slat th was rebut . Again wit	replace the back to to walls were the control of the except the ex	ne originated ander the common the common the common than the contract of the common than the	il (suff eaves. I for th additio elimina	ering from At an ac placement on of ting

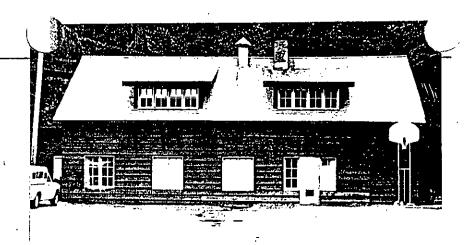
The main	portion of the	e dorm measures	27'x50'	and two subsequent	addition	s, erected at un	nknown	dates,	measure 6'x20'	and
14, CONDITION	☐ EXCELLENT			DETERIORATED	DETERIORATED PUINS 15,		15. DANGER OF DEMOLITION? YES (SPECIFY THREAT)		Пликиоми	_ (
		<u> </u>							•

18'x20' (the side addition and rear addition respectively.) A corrugated metal roof was reportedly replaced with cedar shingles in 1959. In June, 1982 a new fire stair with a corrugated metal roof was installed.

The Dormitory, originally serving as a warehouse building at Longmire, is one of the oldest government-built buildings remaining in the park. The relocated building was converted to a bunk house in an effort to upgrade the existing seasonal employee housing conditions. Thomas C. Vint, Chief Landscape Architect supervised the building's design for its new use in 1929. Associate E. A. Davidson served as field construction supervisor.

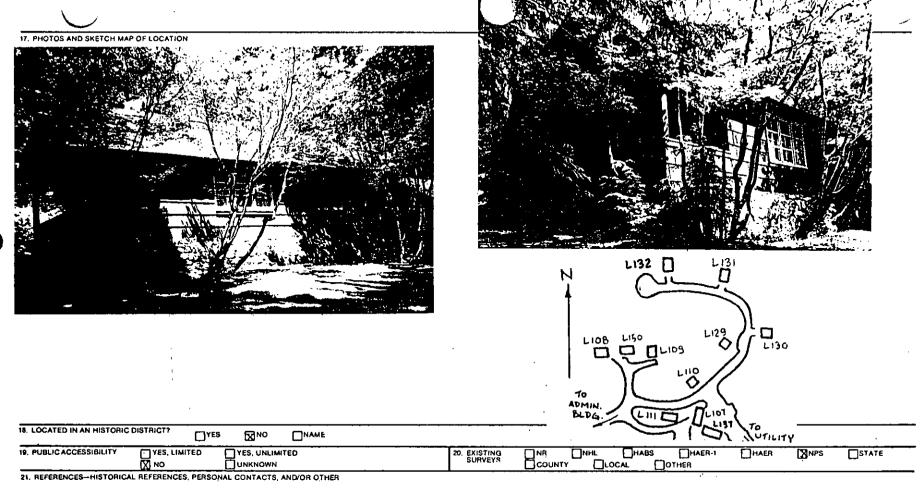
Wood frame, 1-1/2 stories, 7-room, rectangular bungalow; medium pitched cedar shingle gable roof intersects with gable roof over post and beam frame front porch; two stone chimneys on gable ridge; cedar shaked exterior siding over 1 x 12 horizontal lapped board; contemporary storm windows over double hung-two sash windows; stone masonry foundation; finished interior walls are textured wallboard and wainscot; stone masonry fireplace; wood floors.

During Superintendent Roger Toll's administration (1919-1920) the National Park Service's landscape architect in Washington, D.C., was requested to prepare location plans for employee housing at Longmire (Superintendent 1920). Acting Superintendent Clarence Nelson, in his annual report for 1922, also recommended the construction of residences at Longmire to replace temporary tent quarters. L-108, measuring 38.5'x 28.5', was one of the four cottages built by the Park Service at Longmire in 1923. Total floor size for both stories is 1560 sq. ft. The semi-attached woodshed/ garage (see L-150) has a floor size of 450 sq. ft. The open porch is one story, extends half of the width of the front facade, has roughly hewn log columns, and wood decking. The storm windows and the fiberglass insulation under the bottom floor were installed in 1966.

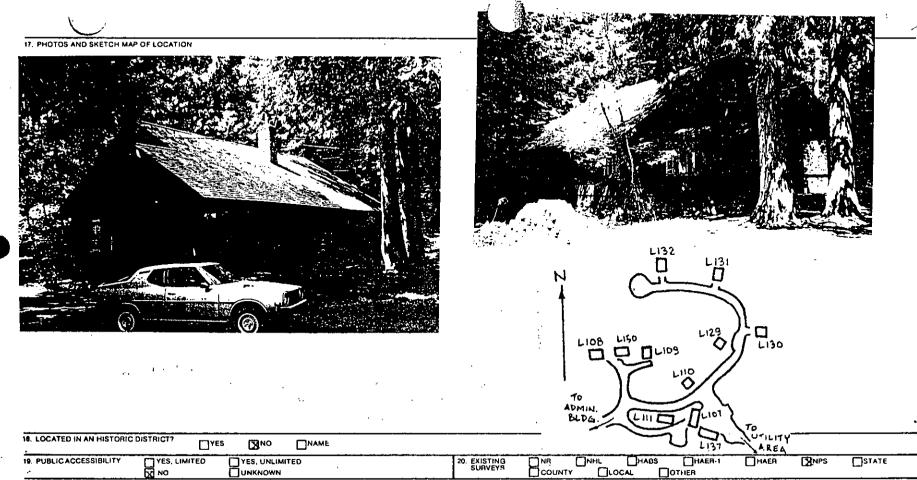
Wood-frame, 1-1/2 story, eight-room (and bath), rectangular bungalow; steeply-pitched cedar shingle gable roof intersects with gable roof over post and beam frame front porch; stone veneer brick chimney off gable ridge: exterior cedar shake siding over 1 x 12 horizontal lapped board; stone foundation; interior walls are finished wallboard: wood floor.

L-109 was constructed from the standard cottage plan as were numerous other residences built at Longmire during that period. These residences were part of the general development plan for Longmire requested by Superintendent Tomlinson and drawn up by the National Park Service's Landscape Design Office in San Francisco, under the supervision of Chief Landscape Architect T.C. Vint.

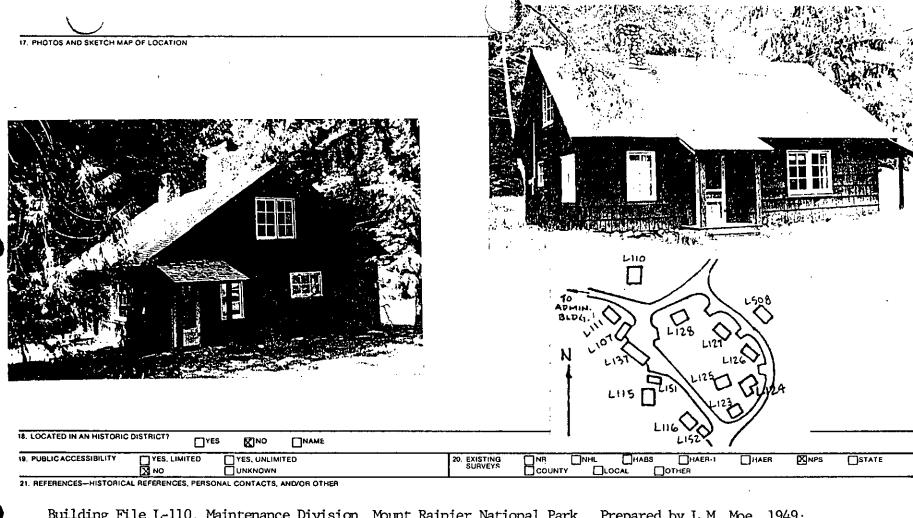
The cottage was one of the first constructed at Longmire for park employees. It was a component of the first planned residential development at Longmire that was proposed during Superintendent Roger Toll's administration (1919-20).

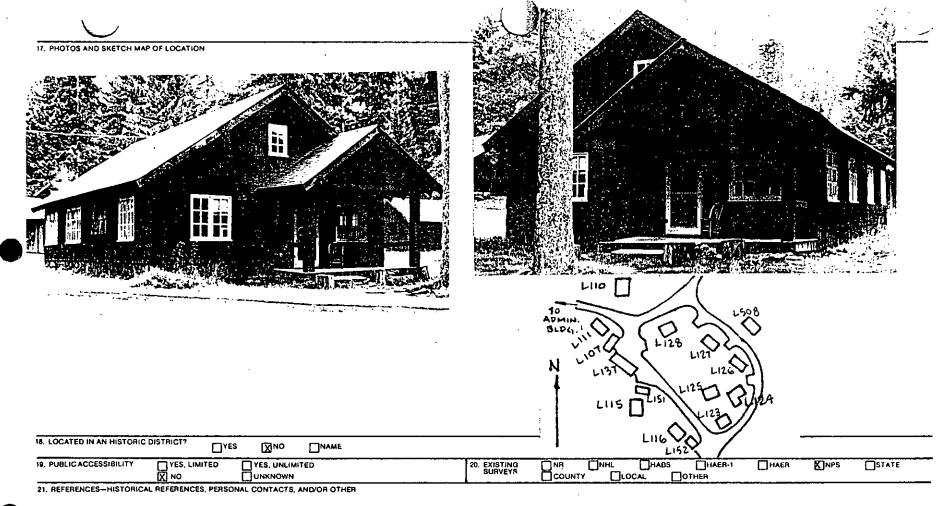
Wood-frame, 1-1/2 story, 6 room (and bath), rectangular structure, medium-pitched cedar shingle gable roof intersects with gable roof over post and beam frame front porch; projecting verges and eaves; stone chimney located off gable ridge; exterior cedar shake siding covers 1x12 horizontal lapped board; stone foundation; interior finished wallboard; wood floors.

L-111 was constructed from the standard cottage plan as were numerous other residences built at Longmire during this period. These residences were part of the general development plan for Longmire requested by Superintendent Tomlinson and drawn up by the National Park Service's Landscape Design office in San Francisco under the supervision of Chief Landscape Architect T. C. Vint

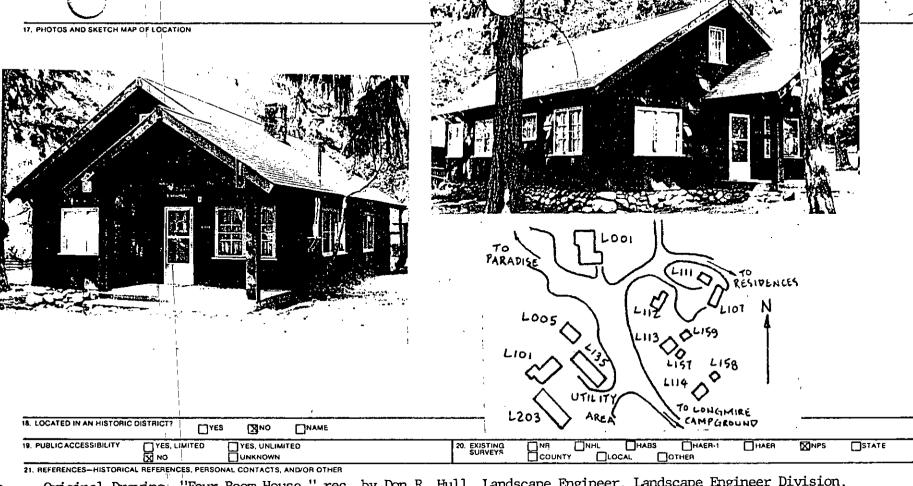
Wood-frame, 1-1/2 story, 8-room (and bath), rectangular bungalow; medium-pitched cedar shingle gable roof intersects with gable roof over open post and beam frame front porch; stone chimney off gable ridge; metal wood stove pipe exterior to side (east) facade; exterior cedar shake siding; finished interior wallboard; wood floors; stone and concrete foundation.

The construction of L-114 was just prior to the initial development plan for Longmire requested by Superintendent Tomlinson and drawn up by the National Park Service's Landscape Design office in San Francisco, under the supervision of Chief Landscape Architect T.C. Vint.

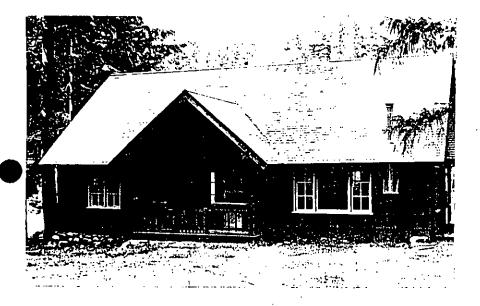
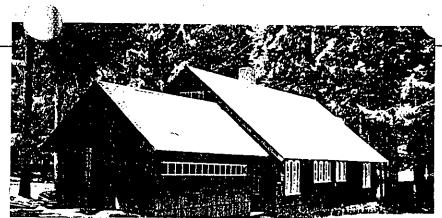
Wood-frame, 1-1/2 story, 7-room (and bath), rectangular residence; steeply-pitched gable roof intersects with medium pitched gable roof over open front porch; cedar roof shingles; projecting verges and eaves; stone chimney on gable ridge; metal wood stove pipe on front roof slope; exterior cedar shake siding; finished interior wallboard; double and triple sash casement windows with mullions; wood floor; stone and concrete foundation.

The construction of L-116 was part of the ongoing development plan for Longmire requested by Sueprintendent Tomlinson and drawn up by the National Park Service's Landscape Design Office in San Francisco, under the supervision of Chief Landscape Architect T. C. Vint.

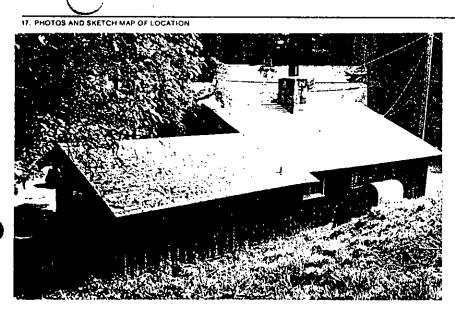
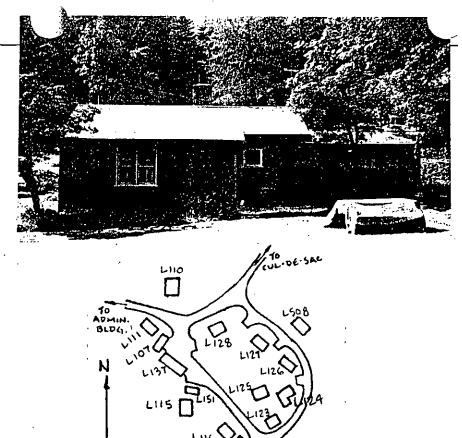
Wood-frame, one-story, four-rooms (and bath); modified rectangular plan; intersecting low-pitch gable roofs with a shed roof extension along half of the front facade; cedar roof shingles; stone veneer brick chimney (with stove pipe) on gable ridge; projecting eaves and verges; exterior walls are vertical board and batten and 1 x 10 vertical rough board with 2" spacing between; windows are double hung, two sashes; concrete foundation; interior walls are wallboard; wood floors. The design for this cottage was similar to a 1936 "Employee Cabin" plan prepared by the NPS Branch of Plans and Design, under the supervision of E.A. Davidson, Associate Landscape Architect (MORA DRG. NO.3144). Built in 193 the structure measures approximately 36' x 30', with a floor size of 700 square feet.			al Park, Ta	homa Woods	-Star Route, Ash	ford, Wa	ashington	· · · · · · · · · · · · · · · · · · ·		7

The construction of L-125 was part of the on-going development plan for Longmire requested by Superintendent Tomlinson and prepared by the NPS Branch of Plans and Design in San Francisco, under the supervision of Chief Landscape Architect T.C. Vint

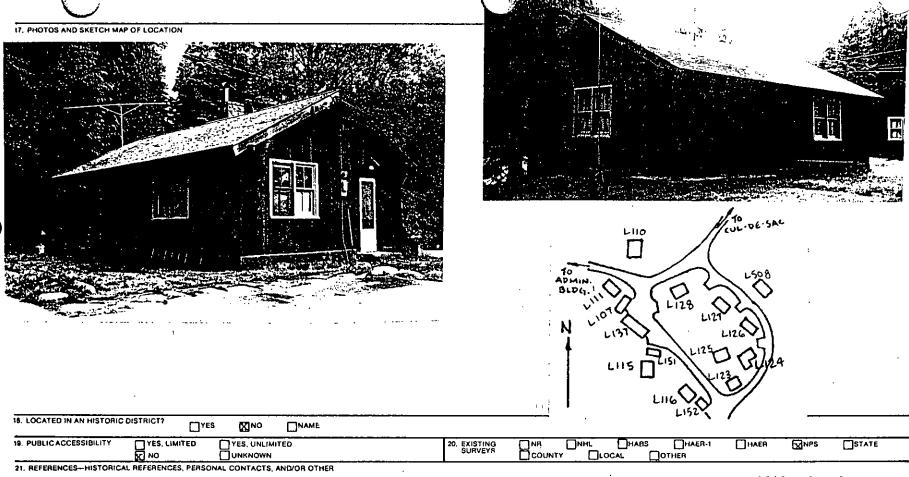
a steep stone	masonry foundation (with	n a partial crawl space,	due to the construc	tion of the residence
on a steep inc	line. The construction	of L-126 by the COC was	an Emergency Conservation Work pr	oject. Built in 1937,
the residence	measures 20' x 30'. The	e recessed front porch l	nas square wood columns and a flag	stone floor. A
small, wooden	stoop is located at the	rear entrance.	-	
·	•			_
				·

L-126 is one of the numerous structures built by the CCC in the park (Thompson 1981; MDRA DRG. NO.2014, 2 sheets). The construction of this cottage was part of the on-going development plan for Longmire requested by Superintendent Tomlinson and prepared by the NPS Branch of Plans and Design in San Francisco, under the supervision of Chief Landscape Architect T.C. Vint

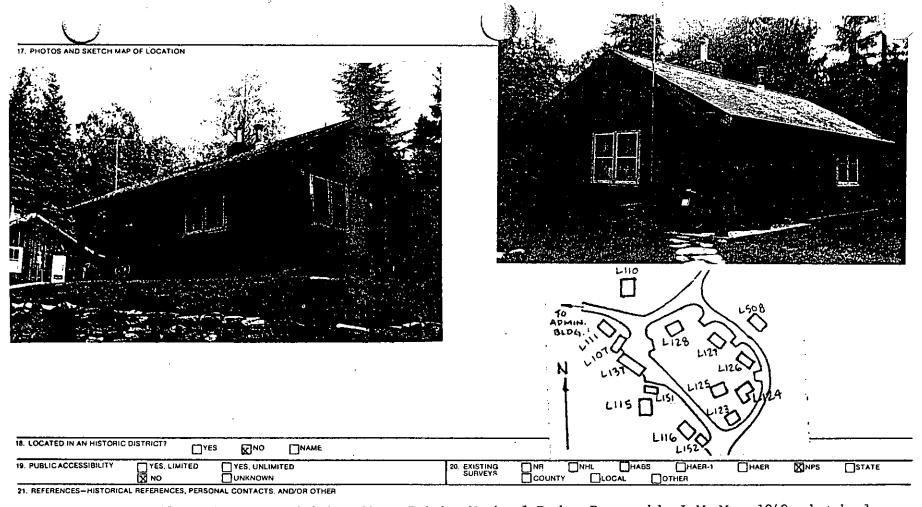
L-127 is one of the numerous structures built by the CCC in the park (Thompson 1981; MORA DRG. NO.2014, 2 sheets). The construction of this cottage was part of the on-going development plan for Longmire requested by Superintendent Tomlinson and prepared by the NPS Branch of Plans and Design in San Francisco, under the supervision of Chief Landscape Architect T.C. Vint,

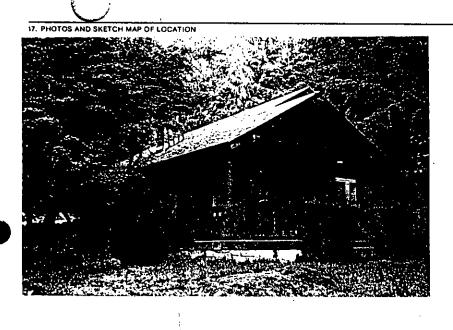
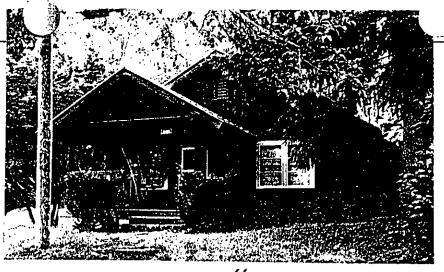
Wood-frame, one-story, four-room (and a bath, partial basement, and rear enclosed porch), modified rectangular structure; intersecting medium pitch cedar shingled gable roofs extend over enclosed rear porch and open front porch, stone veneer brick chimney off gable ridge; cedar shake exterior siding; stone masonry foundation; finished interior wallboard; wood floors.

The employee residence L-128 is one of the numerous structures built by the CCC in the park (MORA DRG. NO.2024; Thompson 1981). The construction of this cottage was part of the on-going development plan for Longmire requested by Superintendent Tomlinson and prepared by the NPS Branch of Plans and Design in San Francisco.

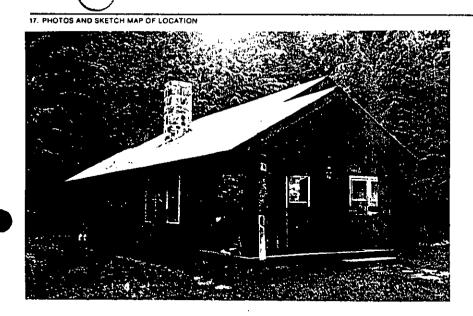
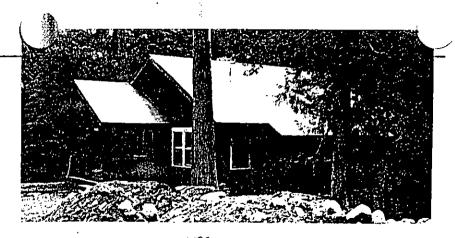
Wood-frame, one-story, four-room (and a bath, partial basement, and rear enclosed porch), modified rectangular structure; intersecting medium pitch cedar shingled gable roofs extend over enclosed rear porch and open front porch, stone veneer brick chimney off gable ridge; cedar shake shingled exterior siding; stone masonry foundation; finished interior wallboard; wood floors.

The employee residence L-129 is one of the numerous structures built by the CCC in the park (MDRA DRG. NO.2024, Thompson 1981). The construction of this cottage was part of the on-going development plan for Longmire requested by Superintendent Tomlinson and prepared by the NPS Branch of Plans and Design in San Francisco.

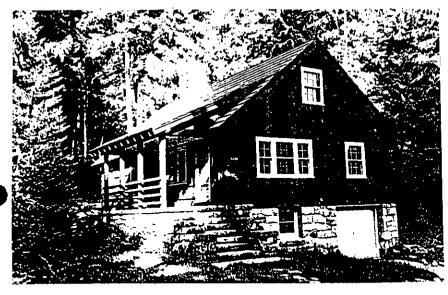
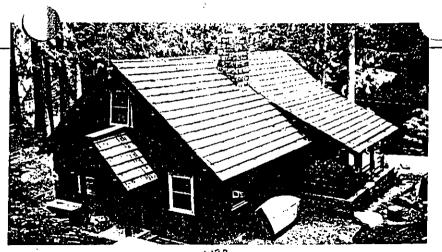
The employee residence L-130 is one of the numerous structures built by the CCC in the park (MDRA DRG. NO.2019; Thompson 1981). The construction of this cottage was part of the on-going development plan for Longmire requested by Superintendent Tomlinson and prepared by the NPS Branch of Plans and Design in San Francisco.

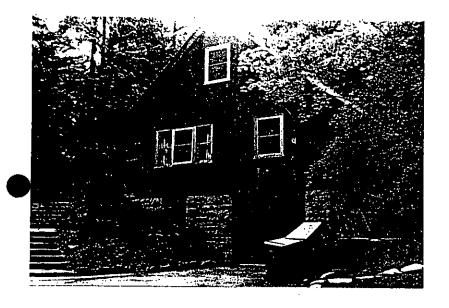
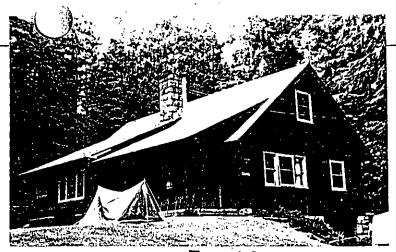
Wood-frame, 1-1/2 story, 5-room (and a bath and partial basement-one bay garage), rectangular structure; steeply pitched cedar shake gable roof; shed roof extension over side porch; native stone chimney to attic, brick to foundation; projecting eaves and verges; windows double hung with two sashes; exterior cedar shake siding; stone masonry porch and partial basement-garage walls; flagstone porch steps and floor; stone masonry foundation; finished interior wallboard; wood floors; side addition.

The employee residence L-132 is one of the numerous structures built by the CCC in the park (MDRA DRG. NO.2019; Thompson 1981). The construction of this cottage was part of the on-going development plan for Longmire requested by Superintendent Tomlinson and prepared by NPS Branch of Plans and Design in San Francisco. This was the last structure to be built at Longmire before Tomlinson's transfer to the San Francisco Office (Thompson 1981).

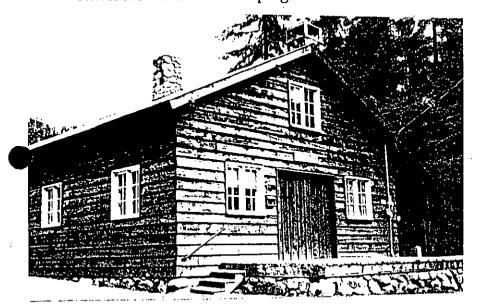
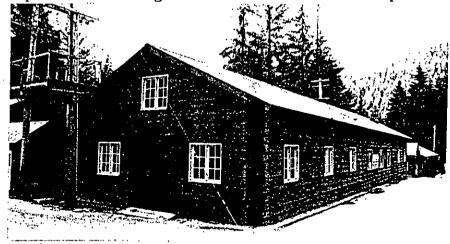
Timber-frame; 1-1/2-stories; rectangular plan; medium-pitched cedar shingle gable roof with projecting eaves and verges; gable extension along the south facade; chimney with stone veneer; rough lapped Douglas Fir siding; timber loading dock; front off center entrance at loading dock, double plank doors; partially finished interior walls and ceilings with sheetrock; casement and sliding glass windows; wood floors; concrete foundation with boulder veneer; 1 story addition of f the south facade (1936).

In 1933, machinery for the production of ice was installed in a room near the loading dock. An 11.5' x 68.5' addition was built along the south facade in 1936; the roof line was extended and casement windows replaced with pivot windows. The loading dock has since been enlarged and three sets of casement windows replaced with sliding glass panels along the north facade. The building continues to serve as a warehouse.

As with other buildings among the utility group at Longmire, Thomas C. Vint, Chief Architect for the National Park Service, Western Division, Branch of Plans and Design, supervised the design. Associate E.A. Davidson supervised

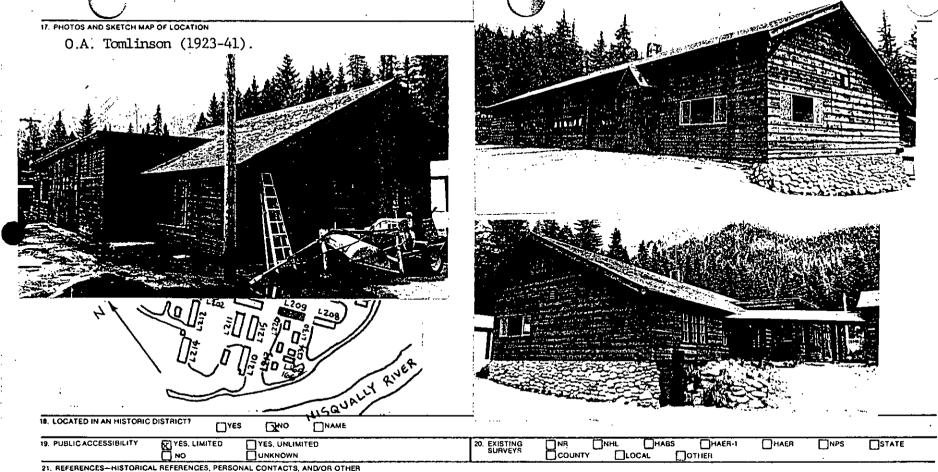
Timber-frame: 1-story over a partial basement: rectangular plan: medium-pitched cedar shingle gable roof with projecting eaves and verges; rough lapped Douglas Fir siding; plank siding doors and galvanized steel. overhead doors; concrete garage floor; concrete foundation; garage interior walls and ceilings finished with wood tongue and groove; office interior finished with wood floors, drywall ceiling and walls, fixed sashes and sliding glass windows; concrete walkway sheltered with cedar shingled gable roof leading to grease storage shed (c.1927); rear shed roof addition (c.1960).

This timber frame building at Longmire was constructed in 1927 by the National Park Service for use as a repair shop. It measures 36' x 112'. The exterior was similar to other utility buildings constructed at Longmire in the mid and late twenties and early thirties; a long cedar shingle gable roof with rear gable extension, rough lapped (1 x 12) siding painted brown and plank garage doors. Thomas C. Vint, Chief Architect for the National Park Service's Western Region supervised the design of numerous utility structures in the park including the repair shop. Associate E.A. Davidson supervised construction. The building contained six garage bays each 11' in width and framed with timber posts and beams. An overhead crane operated along the length of the garage. The interior also included a blacksmith's shop, machine shop, parts storage, repair area with a grease pit, battery shop, washroom and an office.

The garage was secured with sliding plank doors. Subsequent alterations include the removal of the blacksmith's and battery shop, the overhead crane and the infilling of the grease pit. The exterior is largely unaltered though three metal overhead garage doors have replaced plank sliding doors. To the rear, a covered walkway leads to a small timber frame building, constructed c.1927 (see entry of Grease Storage Shed L-220). The repair shop continues to function as such.

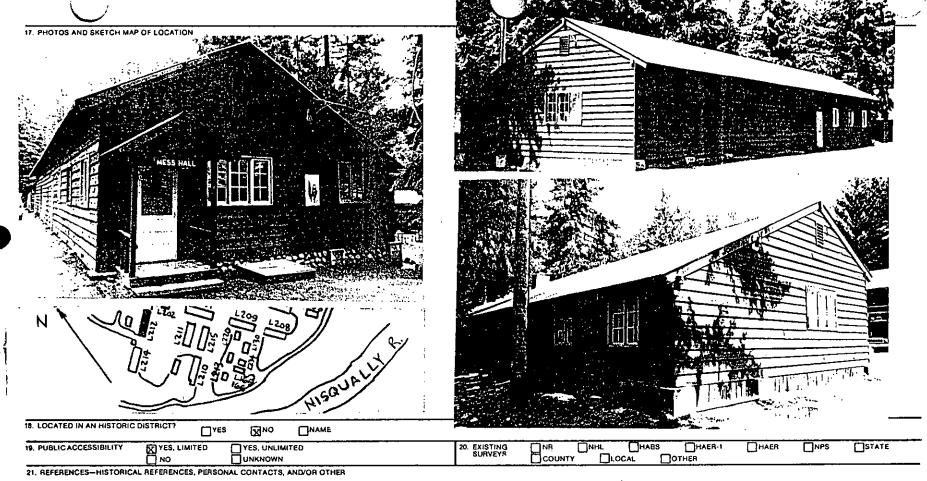
Timber-frame; 1-story; rectangular plan; medium-pitched corrugated metal gable roof with projecting eaves and verges; brick chimney; rough lapped Douglas Fir siding; off center entrance at north end sheltered with corrugated gable roof porch; front and rear off center entrances; wood floor; concrete pier foundation casement windows; interior remodeled for mess hall (1947); mess hall contains kitchen and dining area, finished gypboard walls and ceilings; storage area unfinished interior.

The design and materials of construction are typical of buildings among the Longmire utility group. These facilities were greatly expanded under the superintendency of Major O.A. Tomlinson (1923-1941). Thomas C. Vint, Chief Architect of the NPS Western Regional Office, supervised the design. The converted mess hall is an early example of a public works project at Longmire.

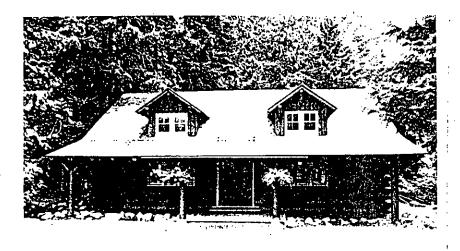
Originally constructed by the Tacoma and Eastern Railroad for use as a hotel clubhouse, it is one of the oldest log buildings remaining in the park. The finely crafted structure was built during the brief era of competition between concessionnaires at Longmire (1906-1920). It is an outstanding example of adaptive use for a park building, currently serving as the Hiker's Information Center.

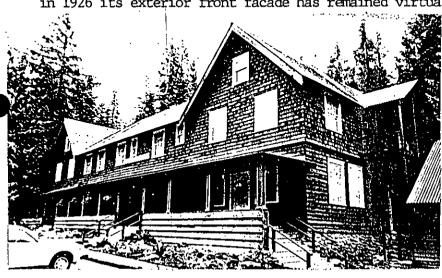
The National Park Inn was constructed during the brief era of competition between concessionaires in the park (1906-1918). Although the building was relocated in 1920 and assumed the name of the original National Park Inn

in 1926 its exterior front facade has remained virtually unaltered.

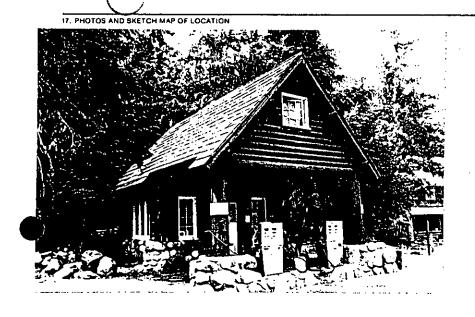
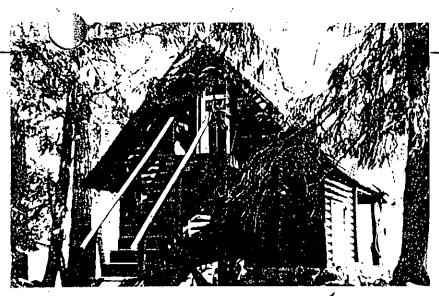
The building's design was approved by the National Park Service's Western Region Branch of Plans and Design with Thomas C. Vint, Chief Architect. It represents the exaggerated rustic style prevalant in Park Service architecture in the twenties and thirties. The service station continues to function as originally intended and remains largely unaltered.

The Longmire Service Station was designated a National Historic Landmark in 1987.
